Overview

The Burlington Hill site is a residential development built in close proximity to the former Asbestos-Talc Products of Washington, Inc. EPA conducted opportunistic reconnaissance sampling at four locations to determine if asbestos was present. At one of the locations sampled, asbestos was identified.

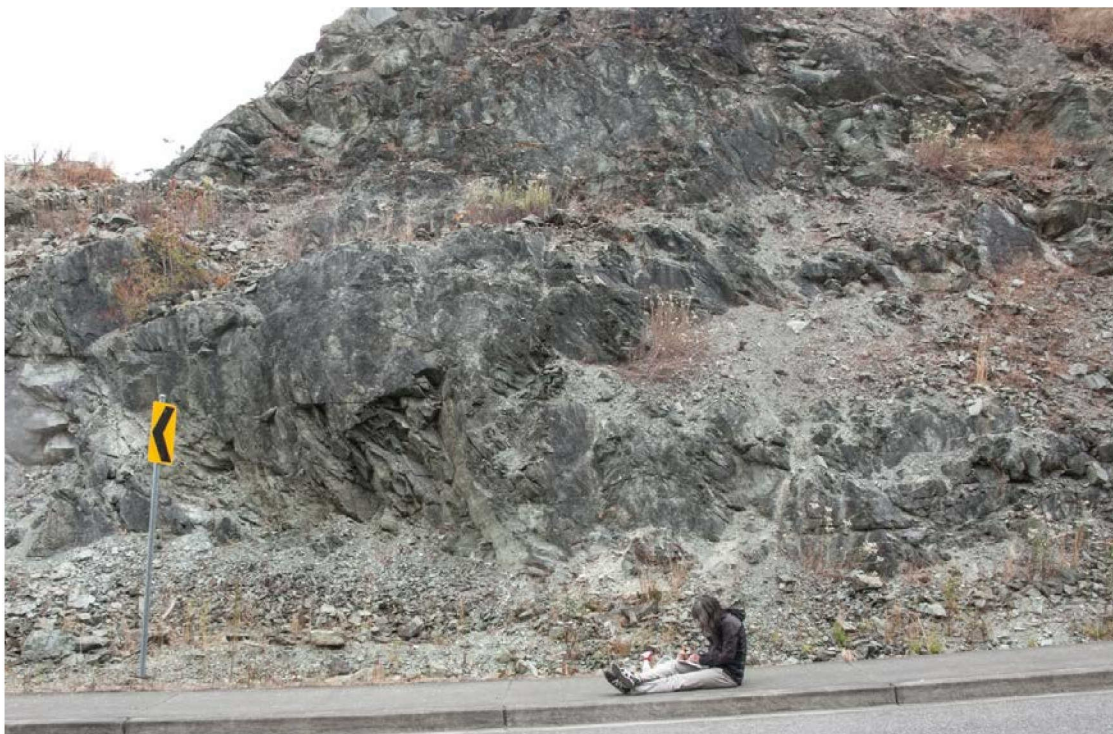
Location 1 (48° 29.223574/122° 19.507260)

The rock throughout the road cut is a highly fractured green schist. Some zones are lighter than others and have a talc consistency.

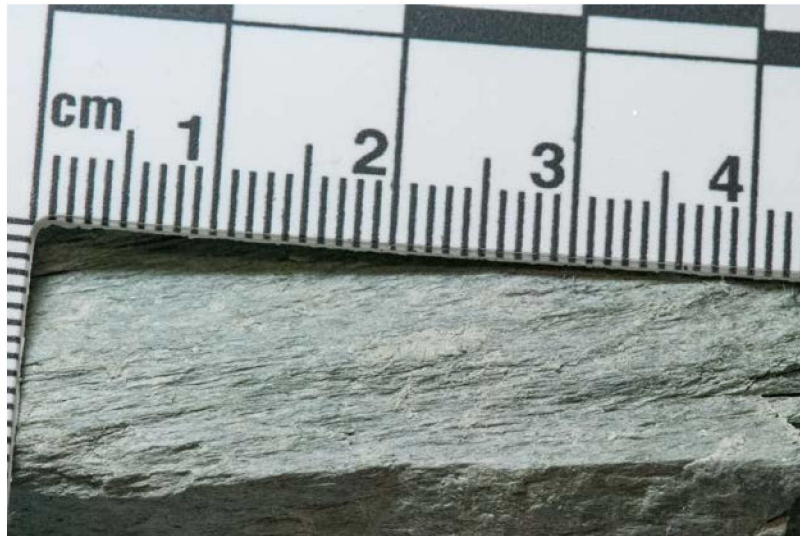
The image above is from the farthest downhill sample for MEL (12090101). Some minor quartz veins are apparent in the hand sample, but nothing obviously fibrous. Material is weathered, fine-grained, light green, and has a talc or soapstone consistency. The texture of the rock is slaty and with no apparent fibers, but there are some small needle-shaped crystals.

MEL also performed SEM/Energy Dispersive Spectroscopy (EDS) and XRD analysis on select samples. PLM images from all 6 samples analyzed by MEL are included in Appendix B. SEM images from samples 12090101 (12394051) and 12090103 (12394053) are also included in Appendix B. EDS confirmed the presence of actinolite in samples 12090101 and 12090103.

Risks associated with potential exposures to actinolite asbestos at Burlington Hill cannot be quantified given the type of data collected. For risk characterization, air samples that measure asbestos concentrations that people could breathe in would be needed. EPA often conducts activity-based sampling (ABS) to characterize asbestos exposures and associated risks. Given the available data, EPA would caution people to refrain from disturbing material in the vicinity of location 1.

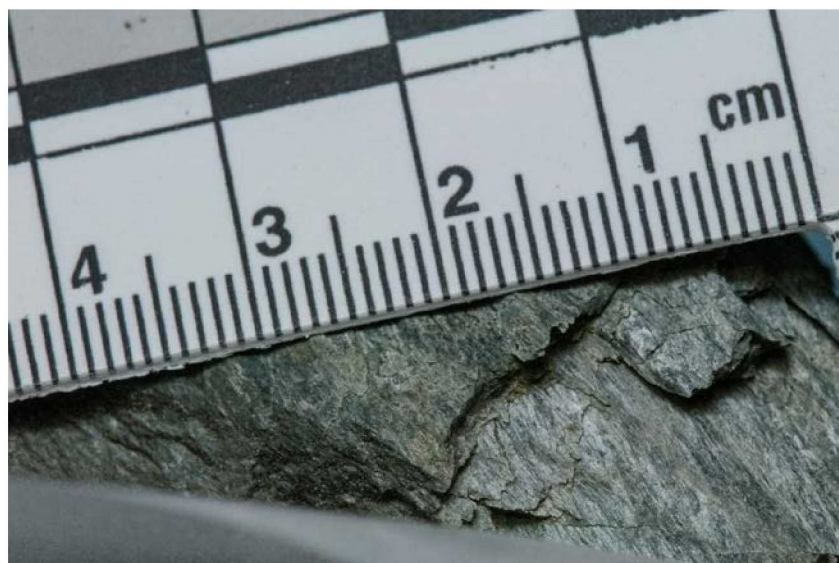
The mid-hill sample from same road cut (i.e., second sample for MEL, 12090103) is slightly up the hill from the previous sample. The rock has a green and very platy texture overall. This sample is also not obviously fibrous, but some fragments are very needle-like. The finer, more weathered material was sampled for PLM analysis (12090104).

The image above is the platy rock collected as MEL 12090103.

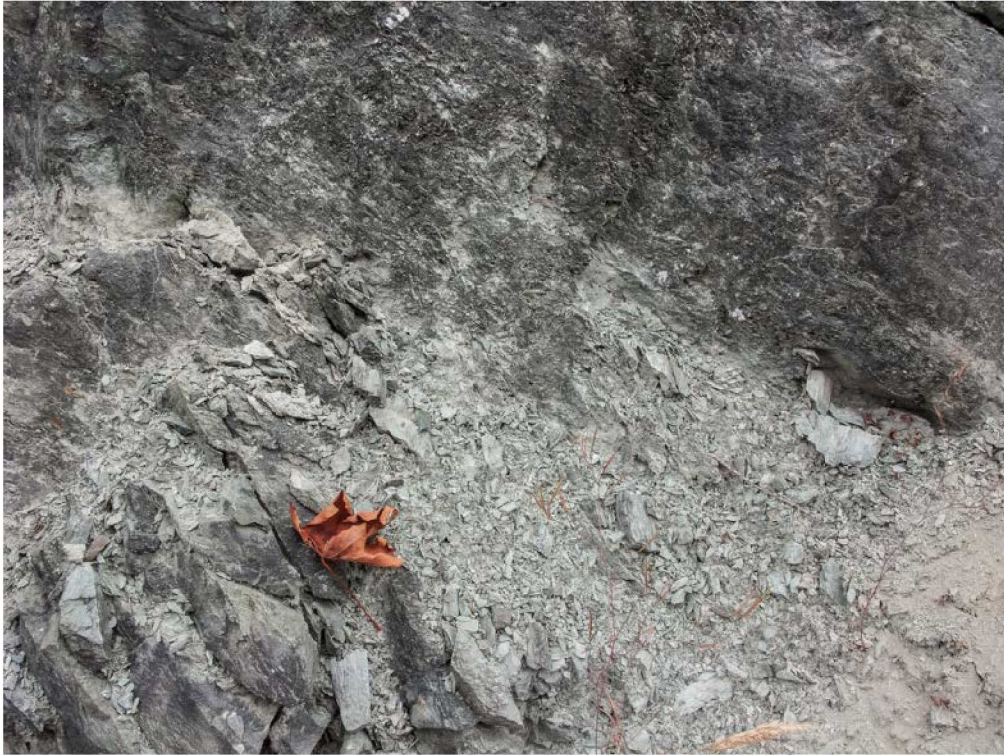
The most uphill sample from the same road cut is for PLM (12090105). This is from some more weathered material, pale green, with a shaly texture and fractures that contain what seems to be a fibrous material, with needle-like structure. This sample was from the uphill edge of the outcrop, just below the cement block retaining wall.

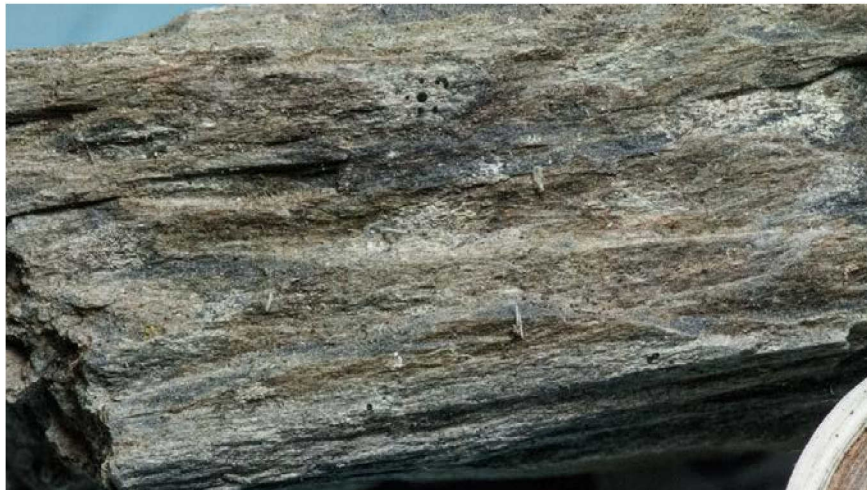
These samples are from a residence on Tinas Coma Drive. The first is from an outcrop to the left of the upper garage door (south of driveway). The rocks here are striated, weathered, and have a sort of "woody" texture from a distance (sample 12090106).

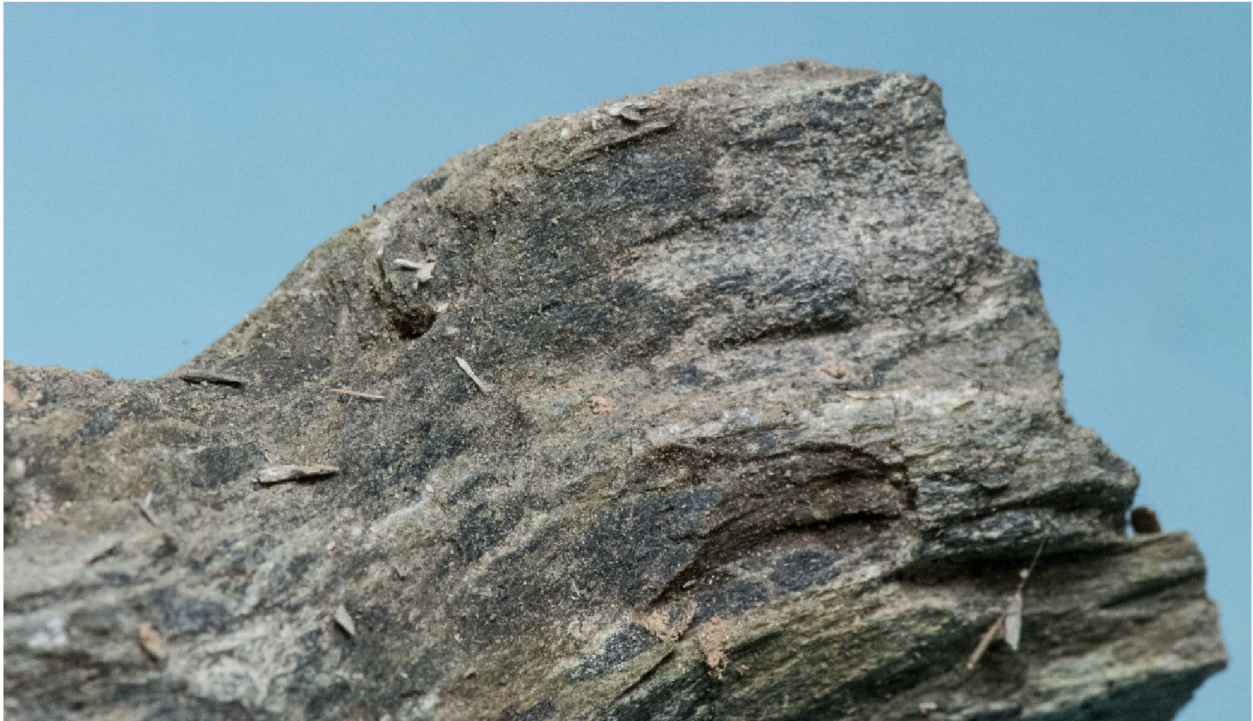
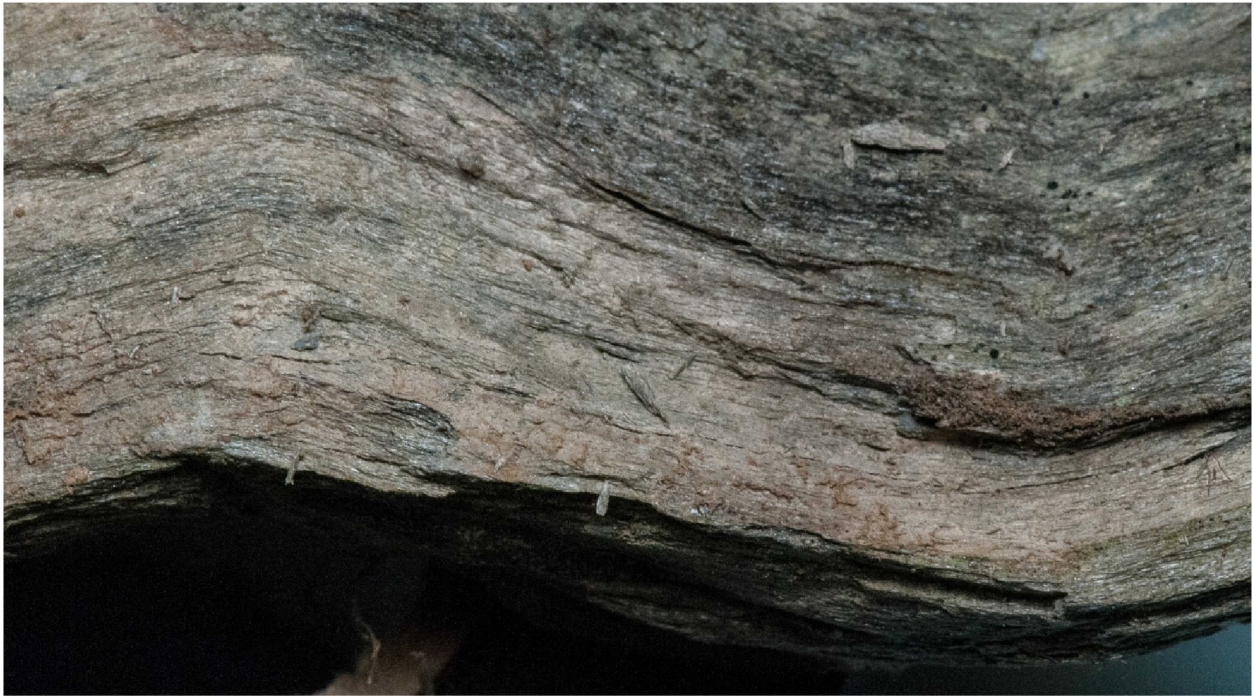
In the hand sample, the texture is very platy and contains needle-like crystals.

The PLM sample collected has some organic matter (12090107). This sample does not show obvious fibers, but has a needle-like texture locally, although most of the rock is platy.

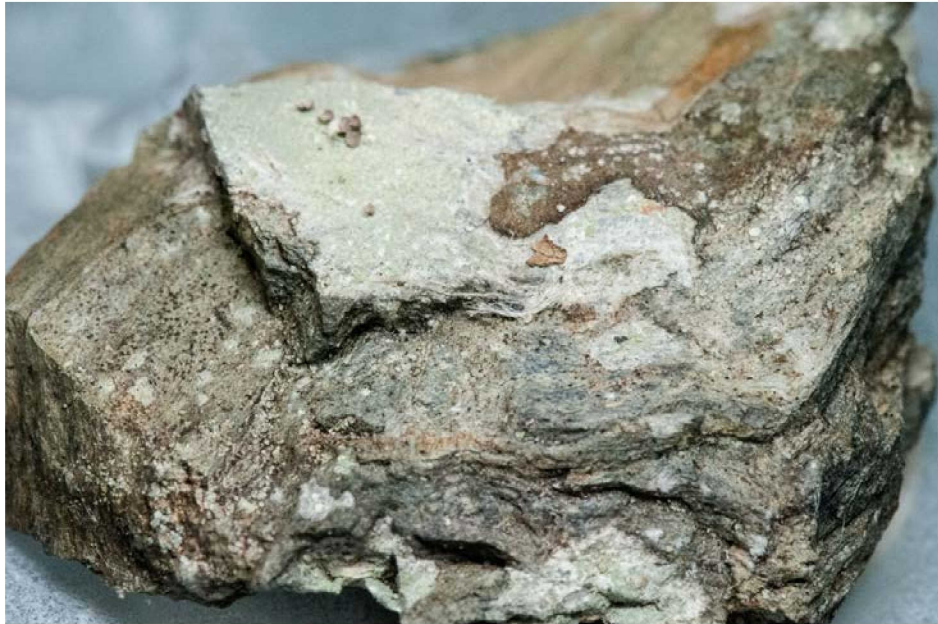
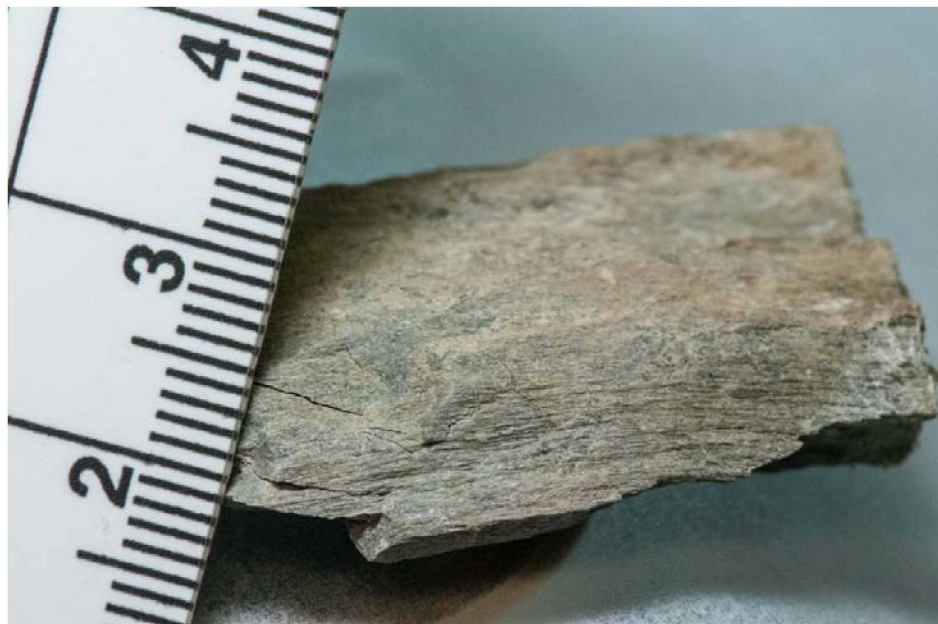
The sample (12090108) collected was farther along driveway, at the garage corner. A fractured surface shows the fibrous material visible with a hand lens.

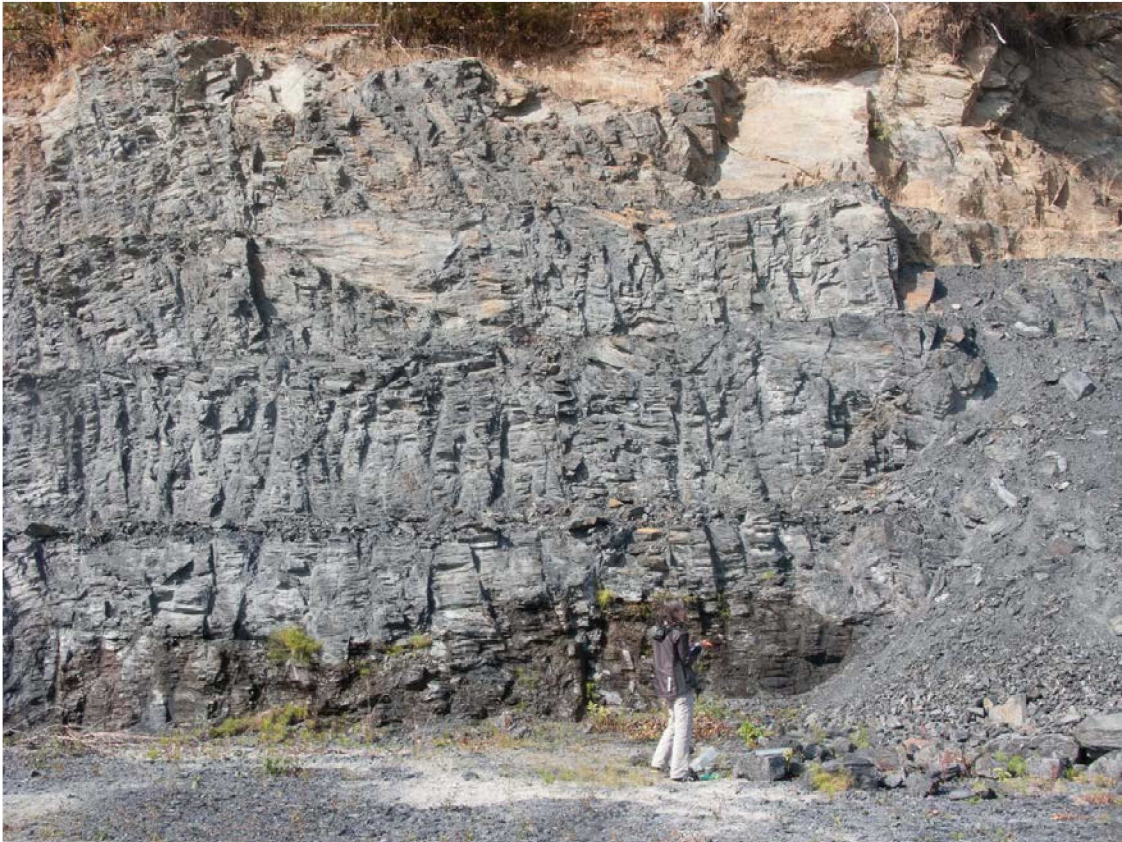
This location is reportedly the old quarry site, and contains remnants from some site preparation for planned condos that were never built. The rock along the back wall is dark gray, almost black, has a slaty texture, but is competent enough to hold a nearly vertical slope.

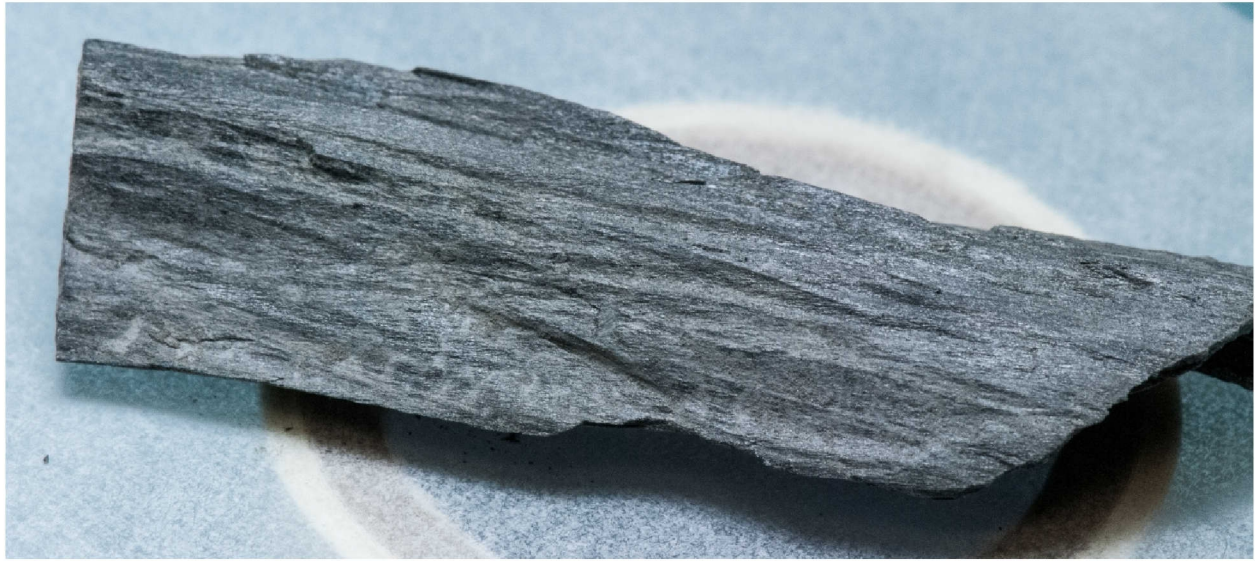
A sample for PLM analysis (above, 12090111) was collected from a more weathered zone at the north end of the quarry wall.

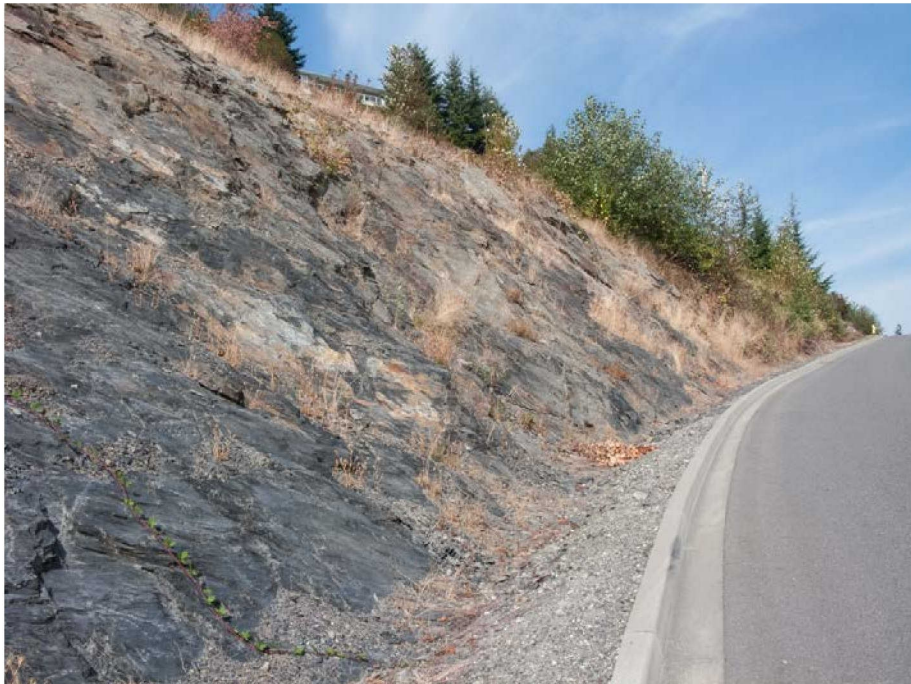
Here the rocks look similar to those seen at Location 3. The light gray-green color and the talc consistency layers observed at Location 1 were not observed here. The rock is more competent and also contains some of the quartz veinlets. At the end of cut (uphill), some of the altered greenish rock with needle-like structures along fractures was observed and sampled (12090113, see below). The rock is dark gray and shaley, and not visibly fibrous, but the thin green fractured surface could be different. No fibers were visible with hand lens, however.

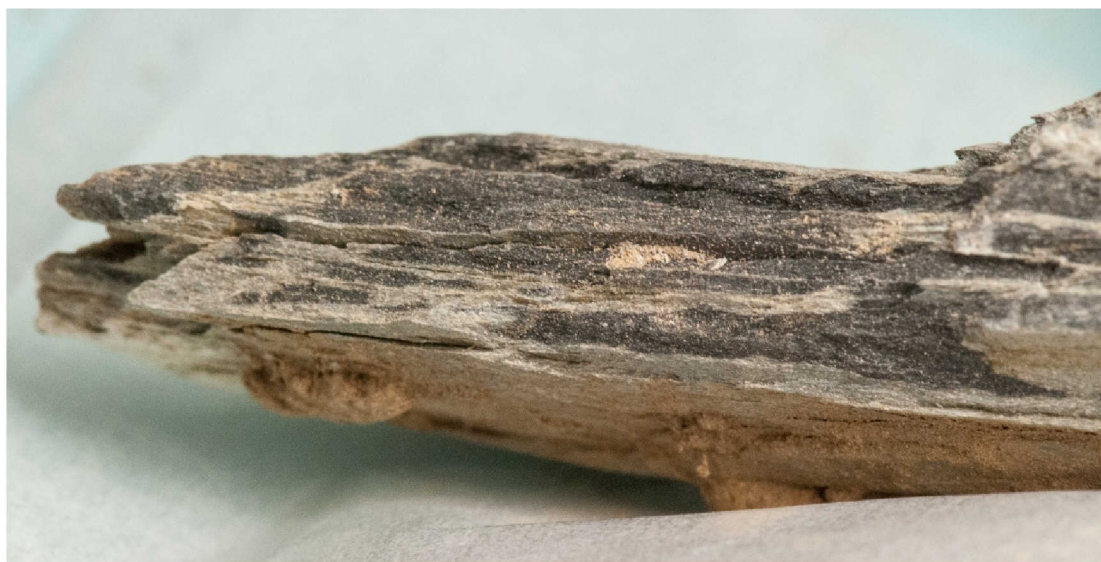
Another sample (12090114) was collected from north (uphill) end of the road cut. A final sample was collected at south end of cut (12090115). Nothing fibrous was observed in the hand sample.
